What to look out for : Just some of the additional hazards we are faced with from day to day.

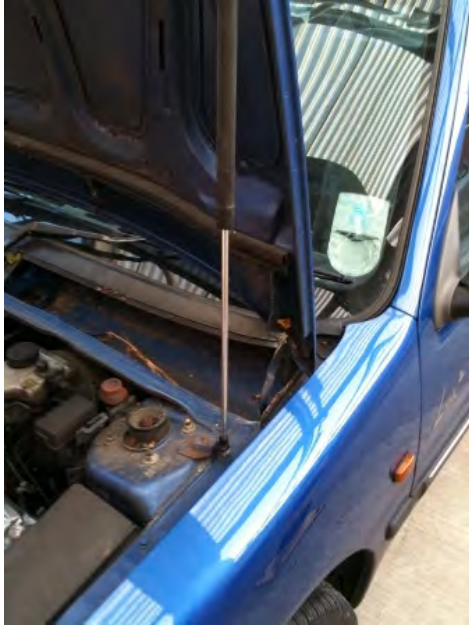
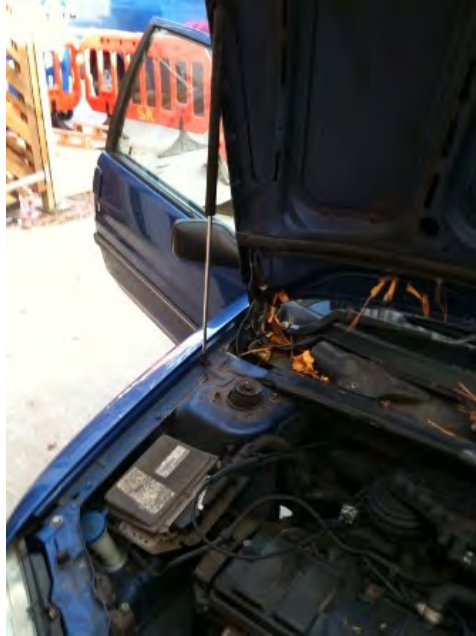
Tailgate struts can be found in the rear of the Cantrail / roof side rails. On Peugeot cars there can be two on each side of the tailgate, where the tailgate opens either as one unit or two separate parts.

The picture you can see in only a Peugeot 106 with gas struts under the bonnet / hood.

Another reason why we need to inspect where we are going to cut, as cutting through a pressurized strut can create a projectile that can cause serious injury. These also pose a hazard in car fires, and can become projectiles from out of the smoke, perhaps Breathing apparatus is not such a bad idea?

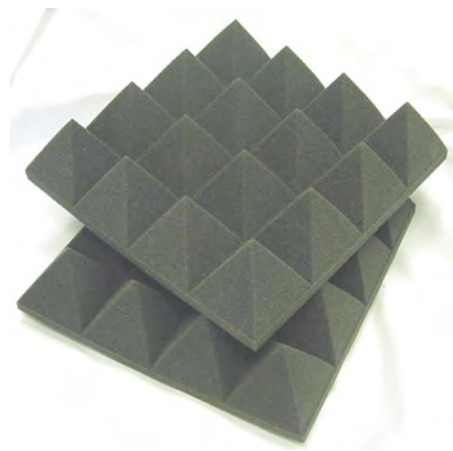
Foam can be found in many vehicles, and is used for structural strength, sound proofing and insulation.

The foam can be found within structural pillars, the dash area and so on. This can pose a hazard when being cut with reciprocating saws as when heated from the blade it will start to give off Isocyanates in the smoke that is produced, this is very toxic and must be avoided.

So if this situation is found it might be an idea to cut these areas with hydraulic tools or similar as this will not cause the foam to burn.

This foam will also create the same hazards during a vehicle fire.
