RTC Rescue MVA Extrication Information - Dealing with new technology

Alternative methods for dealing with New Metals during extrication

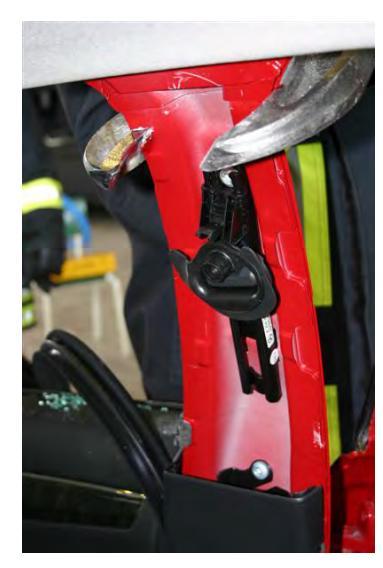
All new vehicles will have a stronger B-post. Avoid the seatbelt attachment bracket as this can always slow down the cutting process (even on a very old vehicle). Most of the time it's the easiest option to cut at the thinnest point (high) on the B-post. Especially if you have a late model cutter, don't mess around with

"V-Cuts", as it slows everything down. IF you are planning to rip-of B-pillars at the bottom this works well, but you definitely need some experience with that technique.

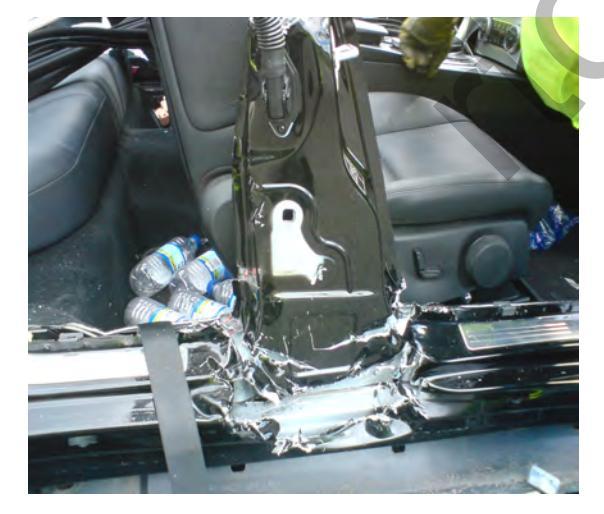
On the left you can see a Brand new Mercedes we were unable to cut the base of the B-post, even after trying as you can see it remained solid.

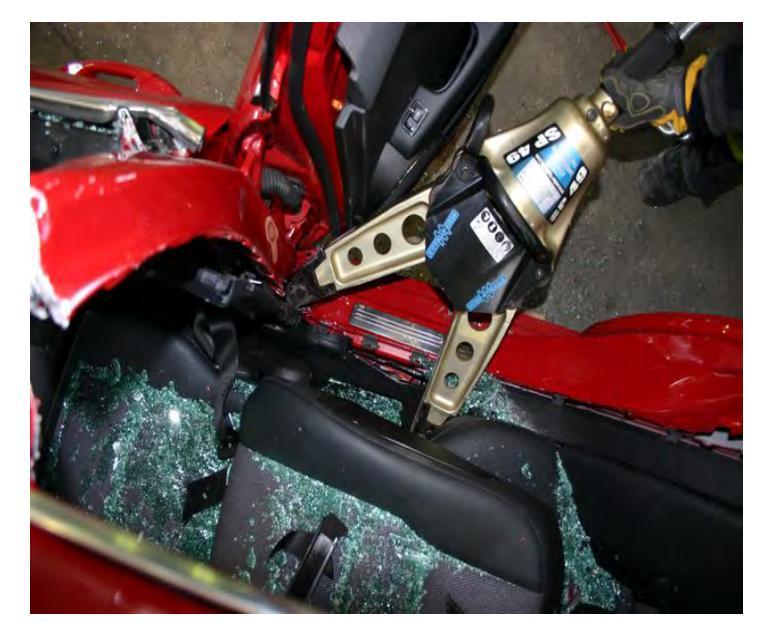
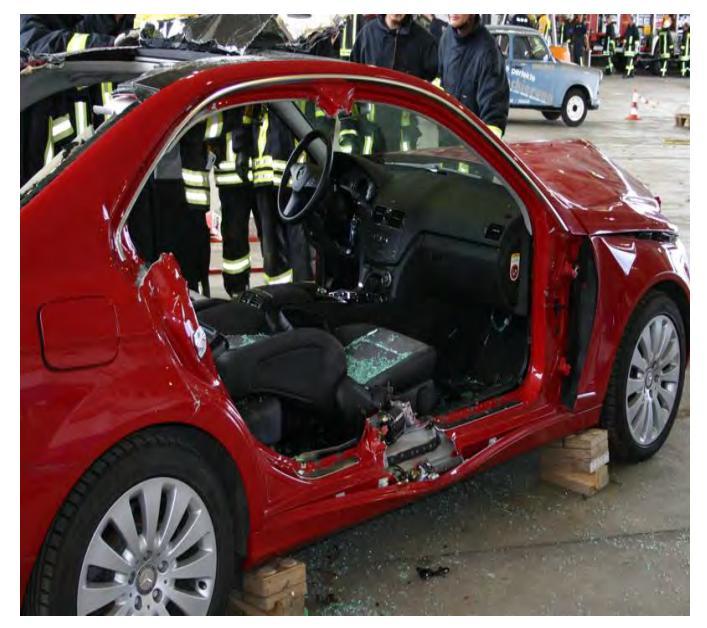
These cuts were carried out on new cars with UHSS components, as you can see ripping the B-post was successful.

But due to the new hardened metals and sheer size of some B-posts at the base this technique is now not so achievable, so we have to go back to ripping the B-post by spreading and tearing the hardened metals of their welds, or simply by just tearing the metal, we may not be able to cut it but it will tear.

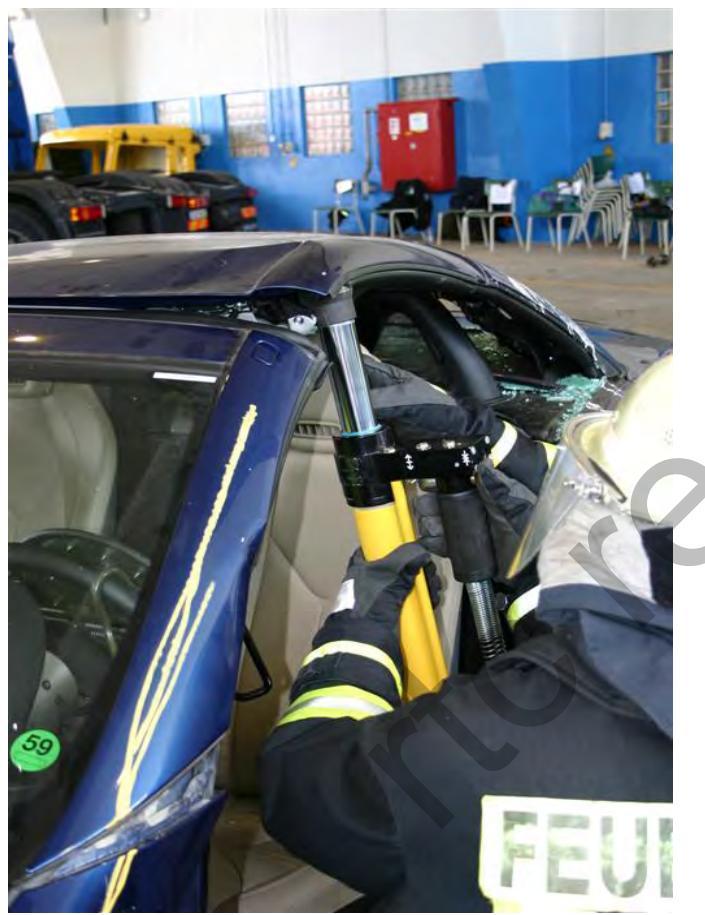
As you can see in the next picture it was possible to ram the A-post and roof apart on a convertible.

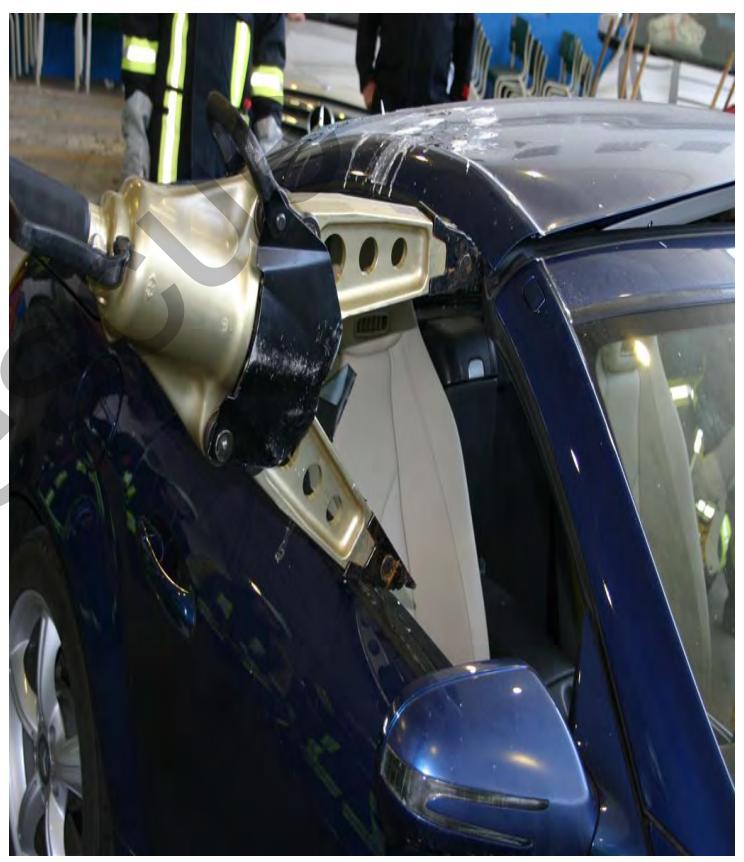
Or alternatively the use of dedicated spreaders worked just as well.

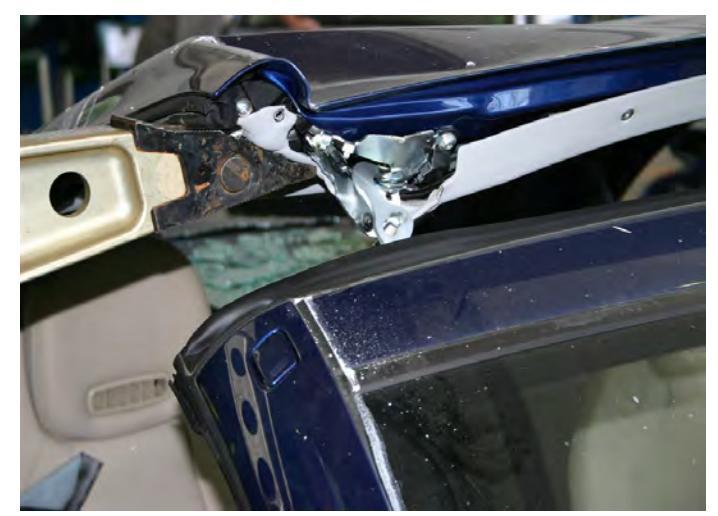
Another method is the tent technique, which does not create maximum space, but where we are unable to cut the roof posts we can give ourselves that bit extra space to work with.

This technique involves ramming or spreading from the rear seat or parcel shelf depending on the vehicle construction and pushing the rear header rail upward to form a tent like shape in the roof, this may give you that extra bit of room to remove the casualty out the back of the vehicle, it doesn't create the best amount of space but when the other options have run out this may just be acceptable.

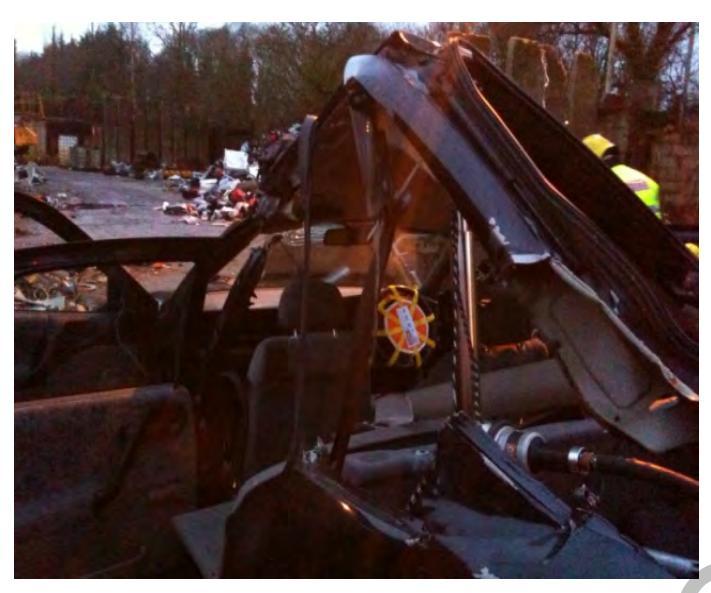
In the following picture you can see during some training just how effective ramming the roof off the B-post can be, we over rammed here just to see what the end result would be.
