The Gull Wing

This is a technique predominantly called the Gull wing in the UK, there are varying names for this method across the globe.

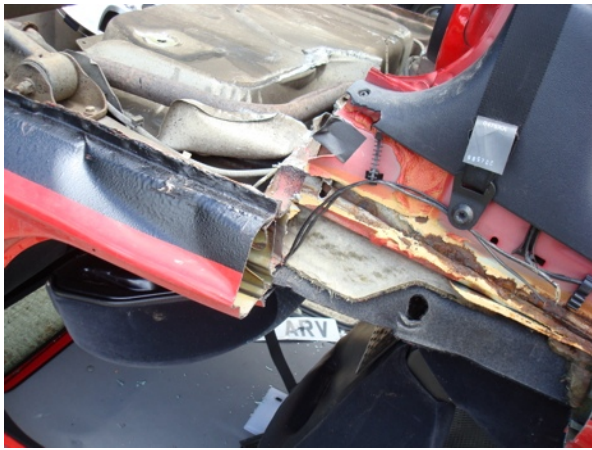
Here you can see we have completed all the cuts with a reciprocating saw as the sill was very weak with the age of the vehicle.

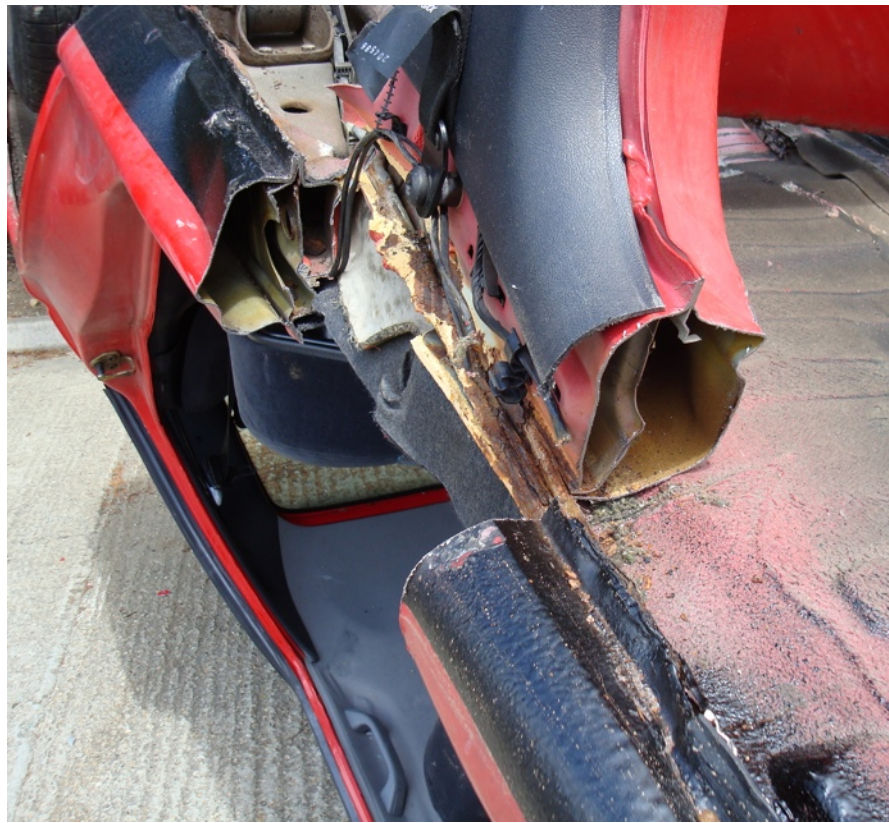
What is also important to look for is additional strengthening in the Sill / rocker channel, as sometimes in newer vehicles we will find a circular strengthening tube that we may not be able to cut through with old cutters or reciprocating saws this will only be visible once you have cut through the outer skin.

What is important to remember is that the cuts need to go through the Sill / rocker channel far enough so that it overcomes the sill strength, ideally all the way to make sure we cut through any structural support in the Sill and floor pan. This will make folding the post a lot easier. Sometimes this can be hampered when using hydraulics if the blades are not large enough to make a deep cut, so several attempts will need to be made to get sufficient depth.

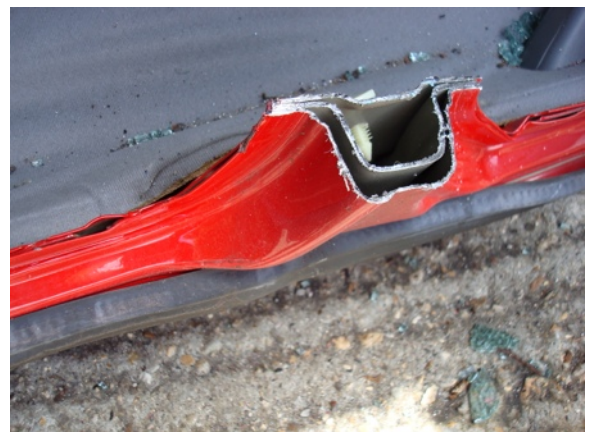
Here we can see the cut in the top of the B-post. A (V) or pie cut would have been a better option to remove the top piece of the post that sticks up. Always remember to check any area we cut for SRS

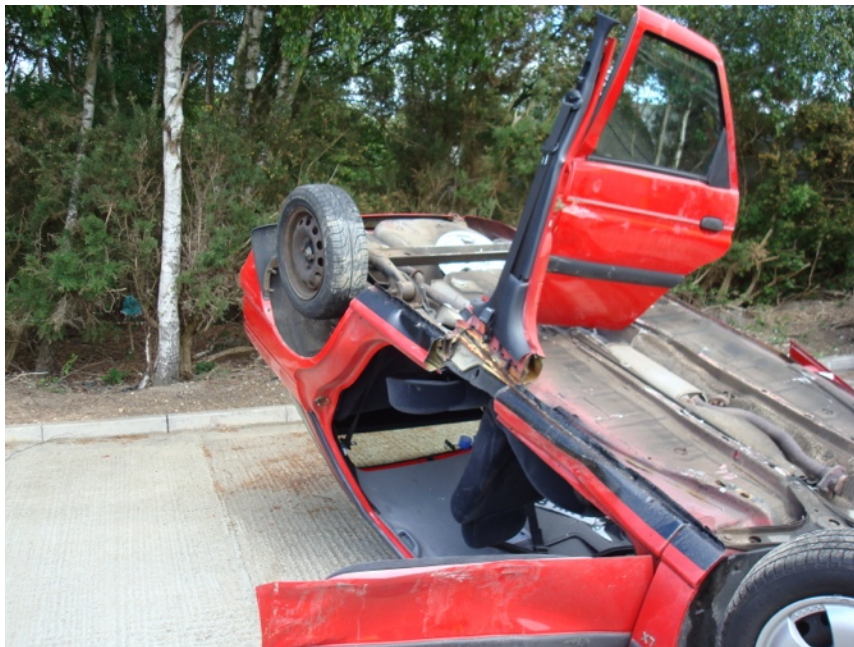
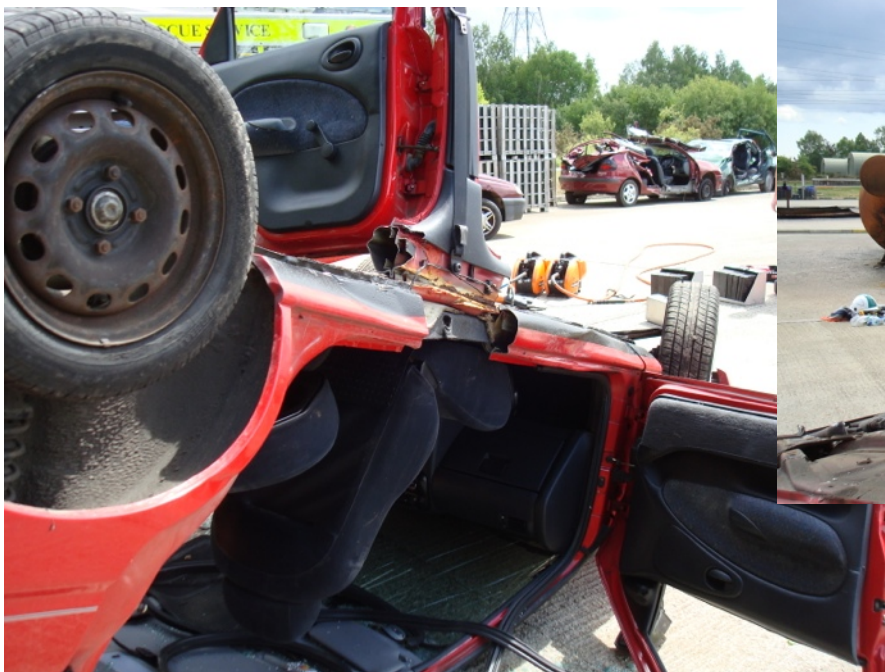
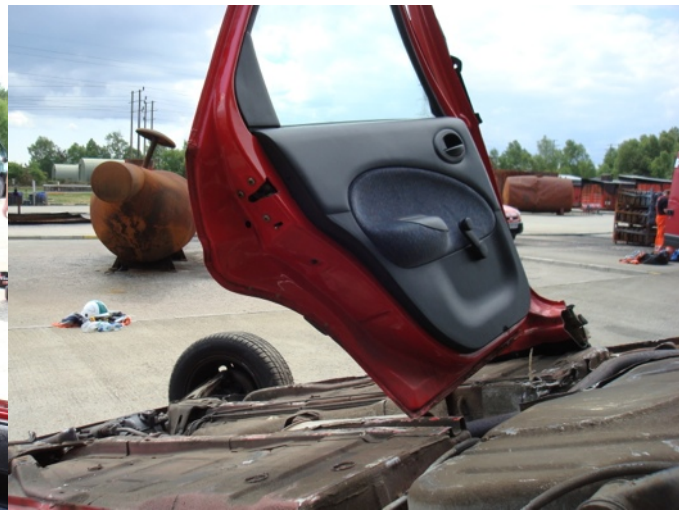
You can see in the pictures the effectiveness of this technique when it works!! As with every extrication method they do not always work to plan or go as smoothly as we would like.

Once the post and door have been flapped they will need securing with a GP line or ratchet system.

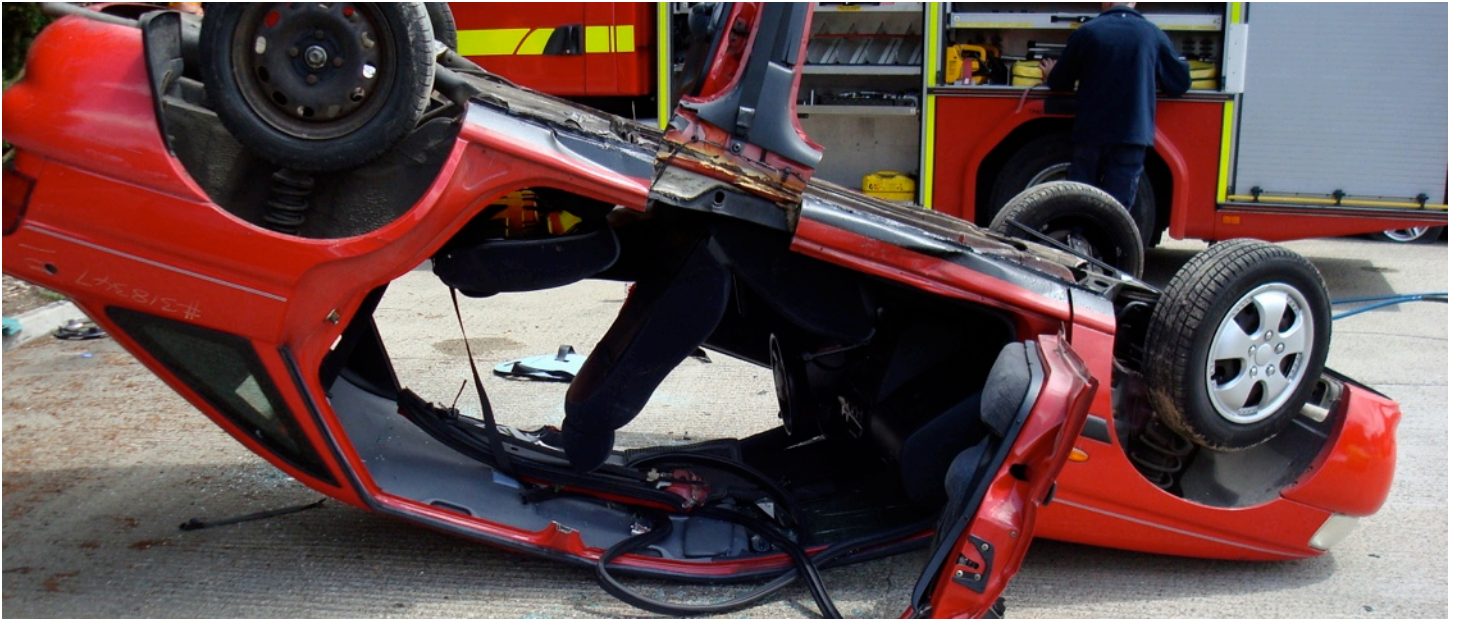
Again here you can see the space we have created for casualty access and removal,

At the time these photo's were taken all stability had been removed.
