DEALING WITH PANORAMIC ROOFS AT RTC'S

This document is a basic guide for rescuers, should you encounter this type of vehicle where space creation is required.

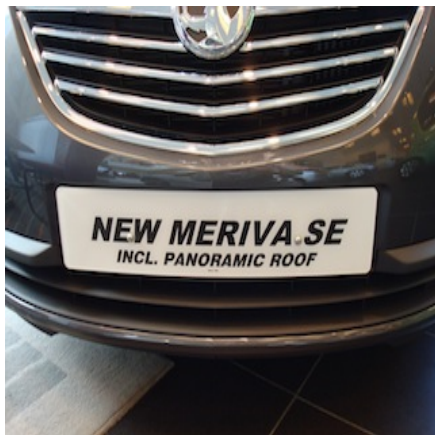
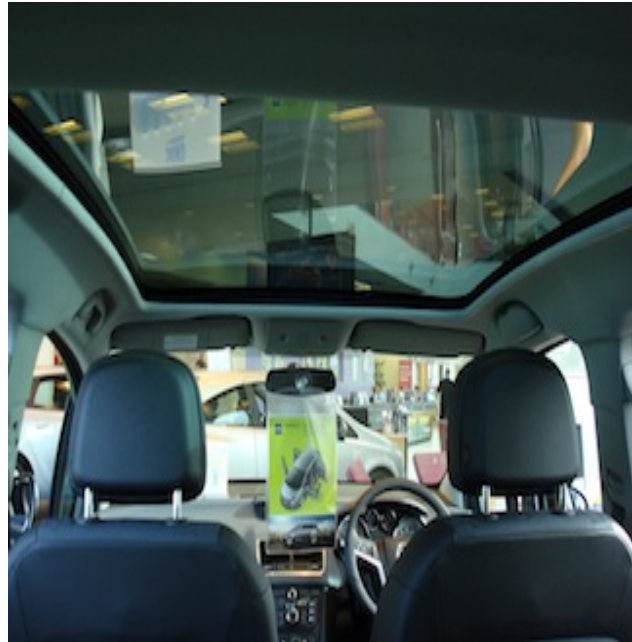
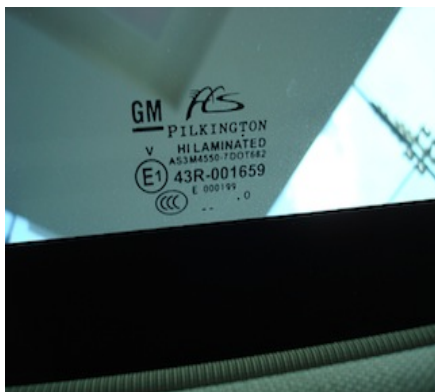
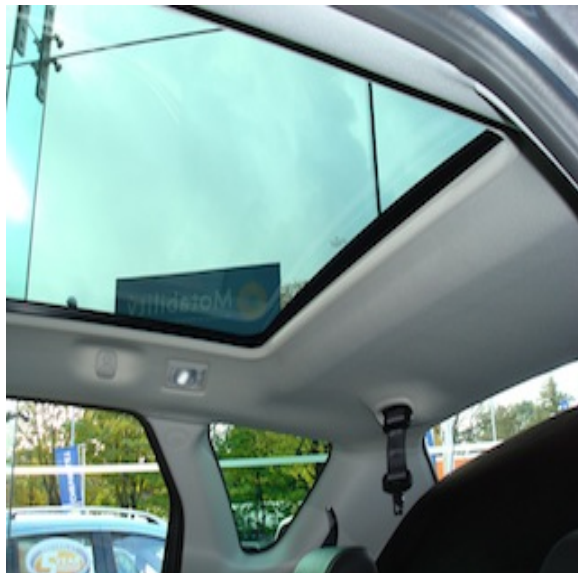
There are many makes of cars that now come with a panoramic roof, most however it is an optional extra. One of the latest being the Vauxhall Meriva which has a complete glass roof made from Laminated glass.

This complete panel is made from Laminated glass.

On the photos of the panoramic roof of the Opel Meriva you showed the glass stamp. For side windows we encountered that the information on the stamp can often provide the type of glass used. The photo you used showed the term laminated, but I've also seen terms like Lamisafe used here. For German built vehicles (Audi, Mercedes, VW) you'll often encounter the abbreviation VSG which is laminated glass. Tempered glass often carries the term tempered. You call it toughened glass, so I assume the term toughened also refers to tempered glass?! The German abbreviation you'll find sometimes is ESG! However, I've no idea what is written on a panoramic roof with Spallshield.

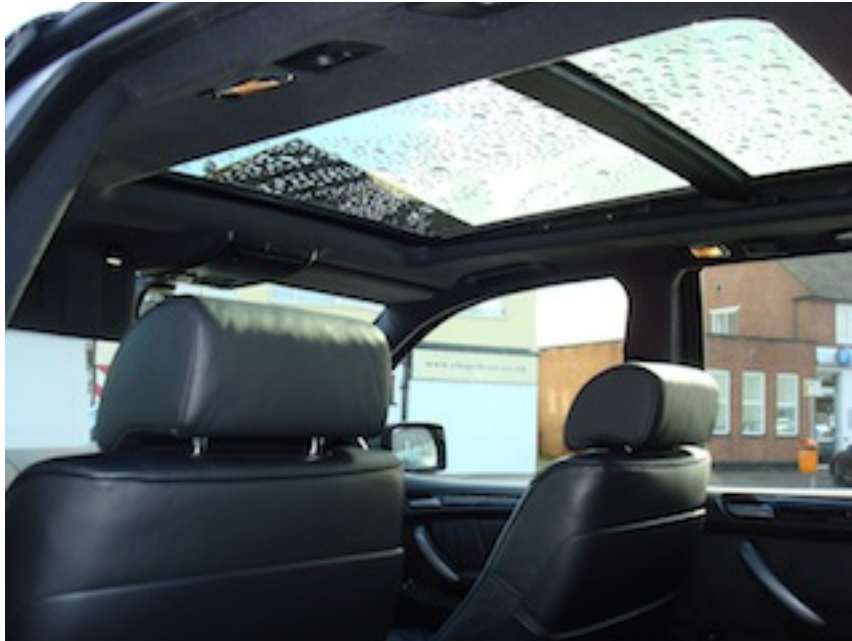
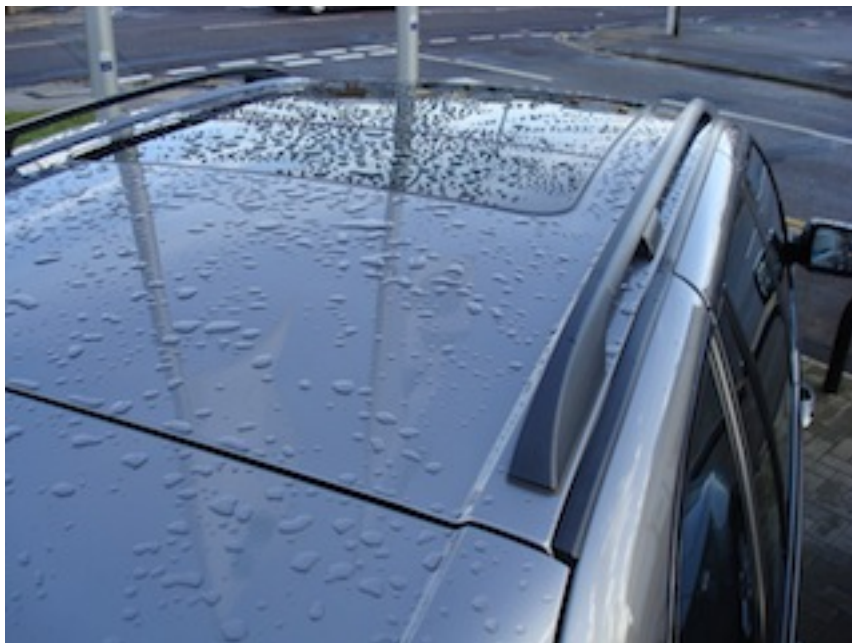
Some vehicle makes such as the BMW X5 will have 2 panes of glass with the front piece opening as a sun roof, now as a rule of thumb the small opening panel will be toughened glass and the larger rear piece will be made from Laminated glass or vice versa.

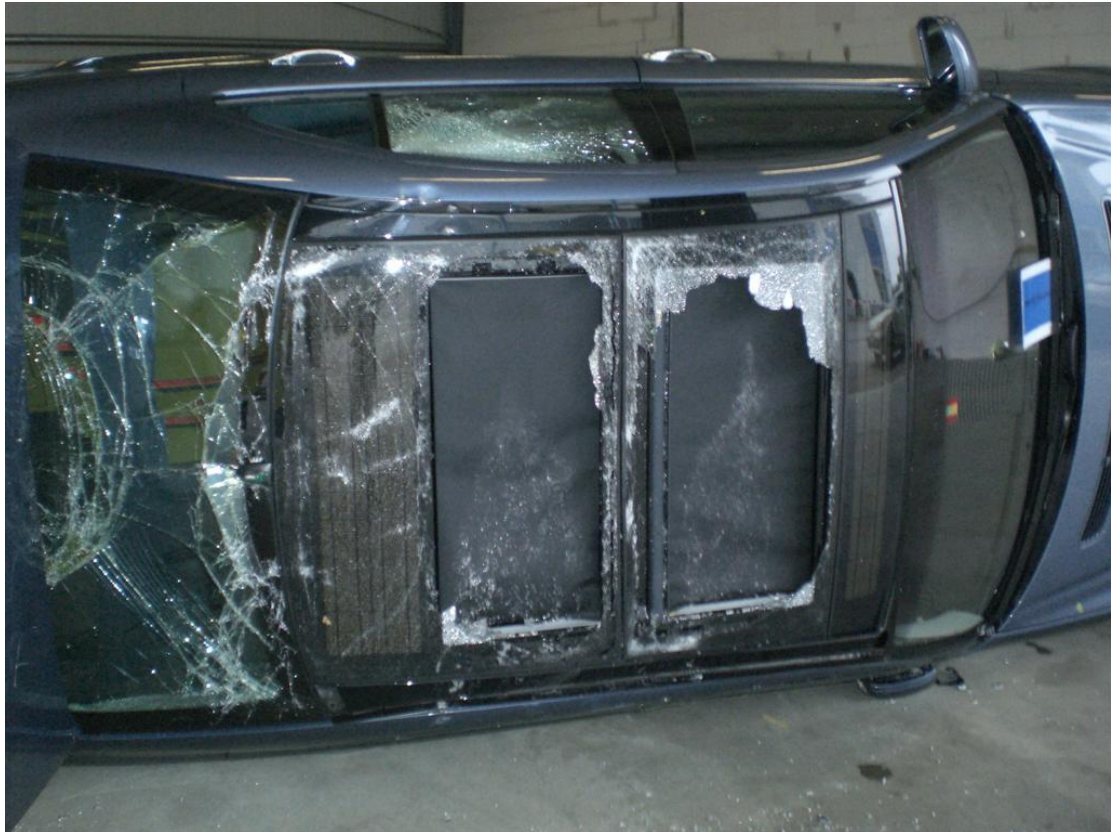
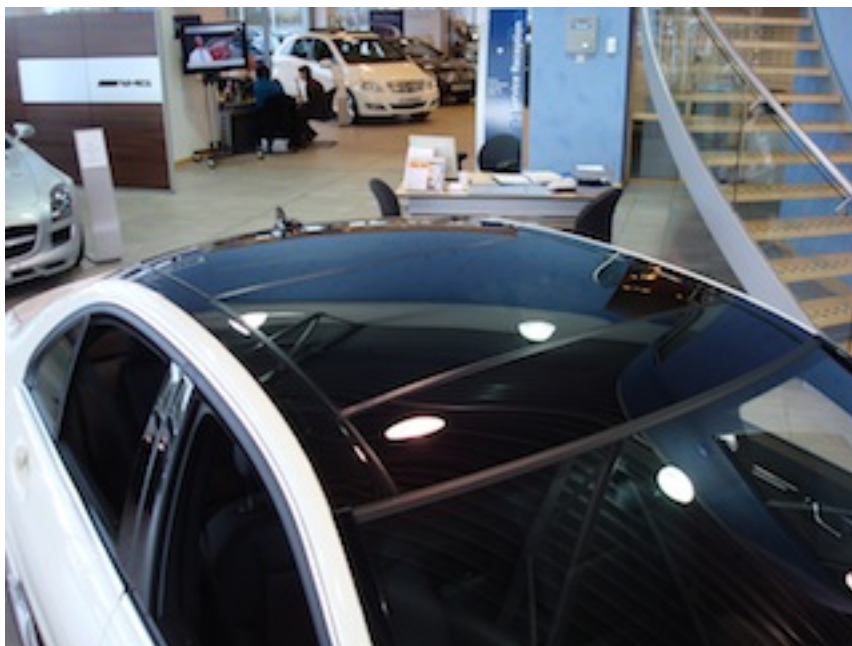
I have been informed that Mercedes fit all panoramic roofs with Laminated glass but as you can see in these pictures this is not the case. The glass here is toughened glass.

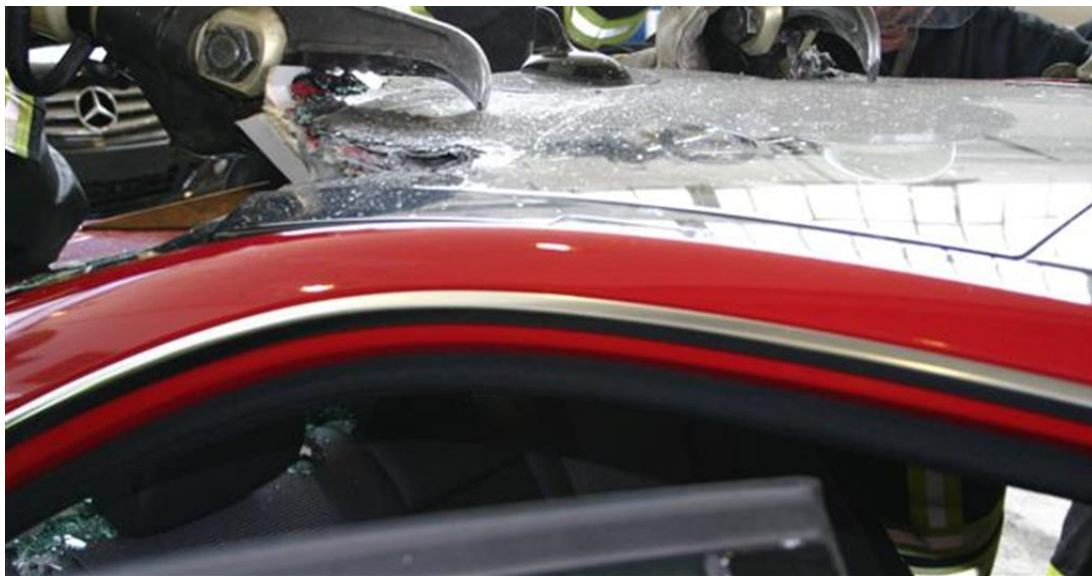
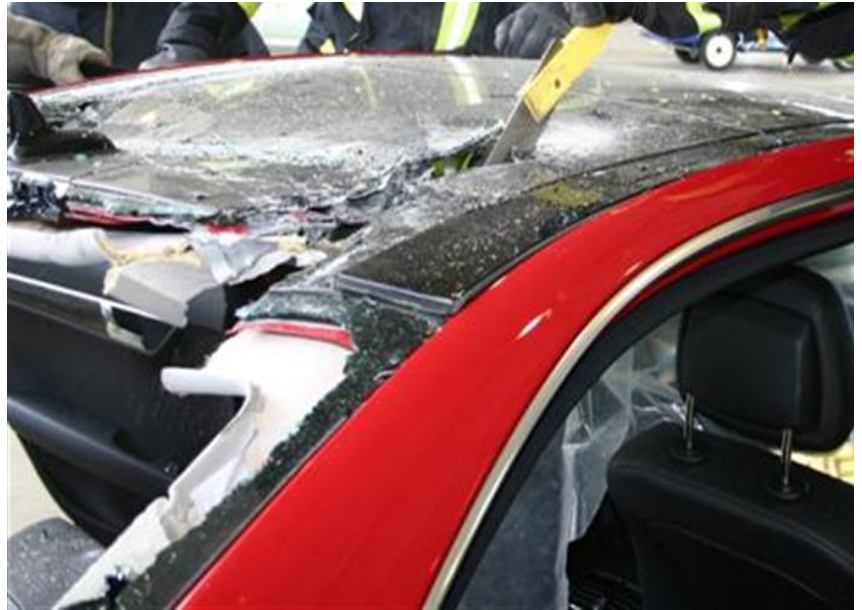
Here we can see the rear section of glass being cut on a Mercedes, where the front piece will be toughened glass like a standard sunroof.

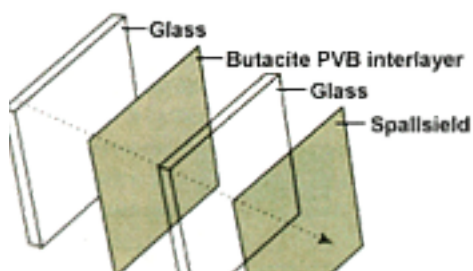
DuPont™ Spallshield® is a three-layer composite structure of PVB/PET/hardcoat. The hardcoat is highly durable, chemically resistant and virtually indistinguishable to glass allowing it to replace one of the lites of glass in a glazing structure. This dramatically reduces the final weight of the glazing.

The Spallshield® coating prevents glass shards on the inside of the vehicle should the glass be damaged in a crash.
